COST AND PERFORMANCE REPORT

Pump and Treat of Contaminated Groundwater at the
Mid-South Wood Products Superfund Site
Mena, Arkansas

September 1998

U.S. Environmental Protection Agency
Office of Solid Waste and Emergency Response
Technology Innovation Office

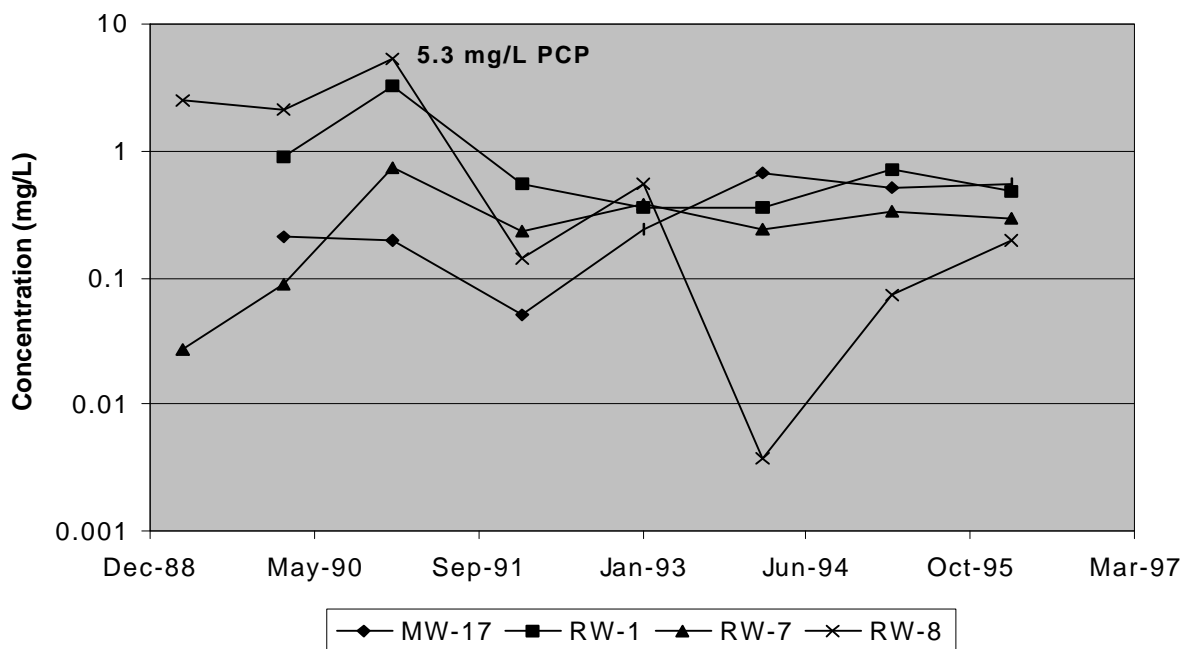
Figure 2. PCP Concentrations in Wells Near Pond Area (April 1989 to May 1996) [4,5,6,7]

- PCP concentrations detected during the May 1996 monitoring were above the cleanup goal of 0.10 mg/L in five wells (RW-1, RW-7, RW-8, RW-15, and M-17). The maximum concentration of PCP detected in May 1996 was 6.6 mg/L (in RW-15, near the former CCA plant). Elevated levels of PCP also showed in the wells near the former pond area (RW-1, RW-7, RW-8, and M-17). Figure 2 illustrates that the PCP concentrations in the monitoring wells near the pond area have declined, but remain above the cleanup goal of 0.10 mg/L.

- An additional recovery well is planned near the waste pond. Monitoring well data have shown that contaminants in the groundwater in this area were not being remediated as quickly as other areas of the site [7].
- Monitoring wells M-17 (near CCA Plant) and MW-19 (near Old Pond) are scheduled to be over drilled in June 1998 and replaced with recovery wells. IWE will be over drilled and plugged.

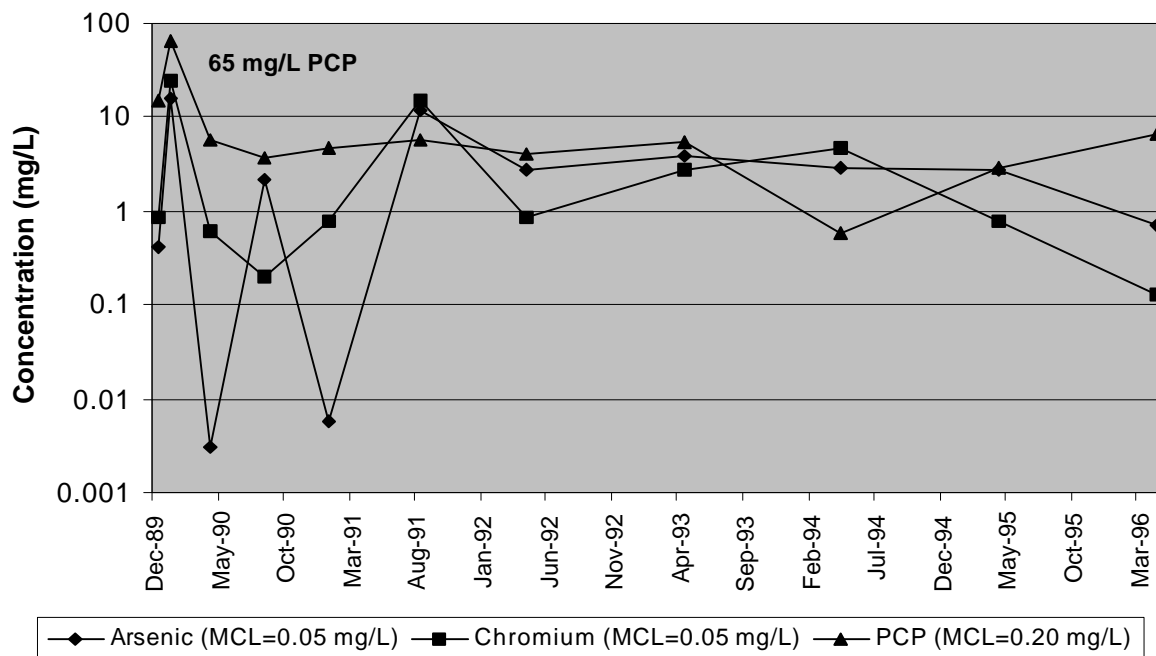
Figure 3. Contaminant Concentrations in RW-15, Near CCA Plant (April 1989 to May 1996) [4,5,6,7]

- RW-15 remains the well with the highest levels of contaminants, specifically arsenic, chromium, and PCP. This well is located 100 feet downgradient of the CCA plant and upgradient of the pond area. The contamination found in this well reflects its proximity to both the CCA plant and the location of the old PCP plant. Overall, contaminant concentrations in this well have decreased during remedial operations (see Figure 3). Reasons for the sharp spikes in concentrations seen in both the first quarter of 1990 and the third quarter of 1991 are not known [9]. By the second quarter in 1996, concentrations of all three of the contaminants remained above remedial goals [7].

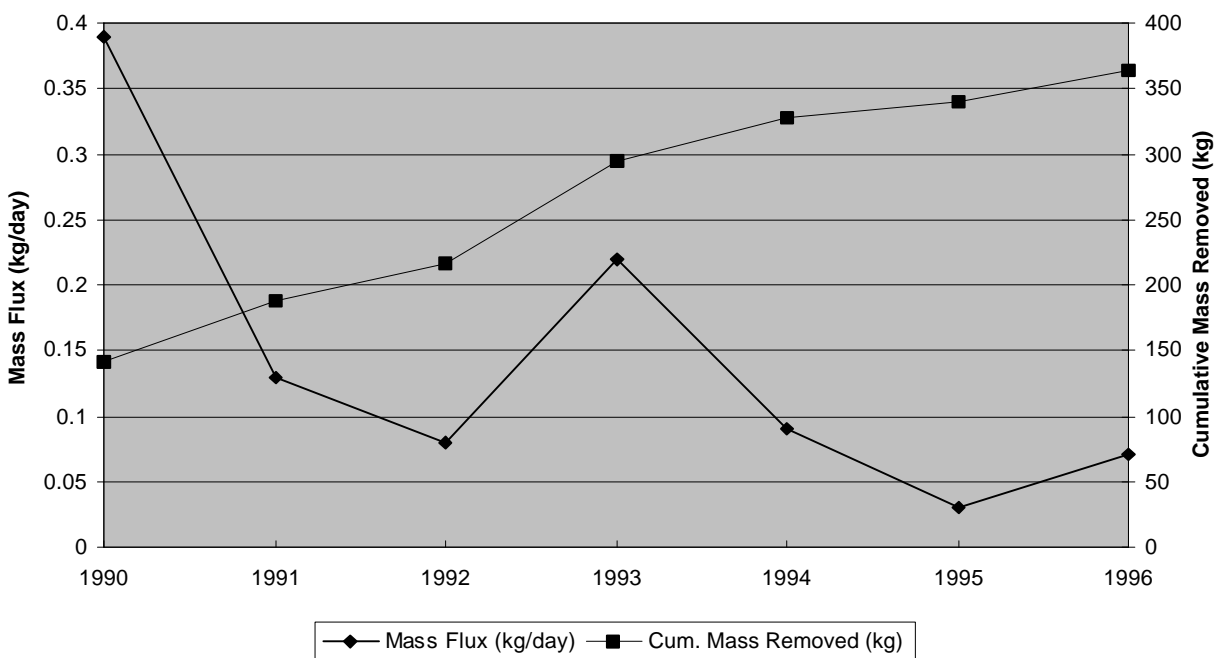
Figure 4. Mass Flux Rate and Cumulative PCP Removal (1990 to 1994) [5]

- Figure 4 presents the removal of contaminants through the treatment system from 1990 to 1996. Over this period, a total of 93 million gallons of groundwater were treated, at a daily average treatment rate of 24 gpm.

- PCP removal rates, reported in annual performance reports, declined from 0.39 kg/day in 1990 to 0.03 kg/day in 1995.

- The increase in mass flux seen in 1993 may be attributed to an increase in precipitation during the year. The increased precipitation could have accelerated groundwater flows, which would then cause a contaminant level increase in the recovery wells.
